Design Guide

for Improving School Safety in Earthquakes, Floods,
and High Winds

FEMA P-424 / December 2010

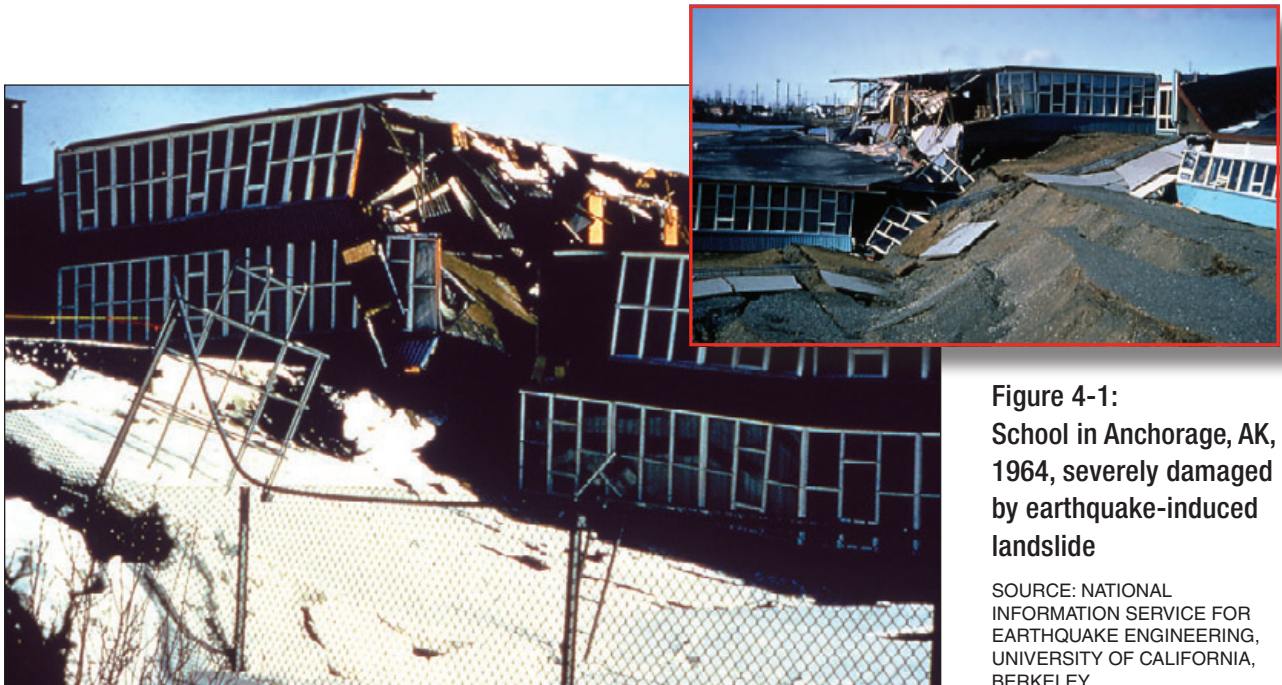
Figure 4-1:
School in Anchorage, AK,
1964, severely damaged
by earthquake-induced
landslide

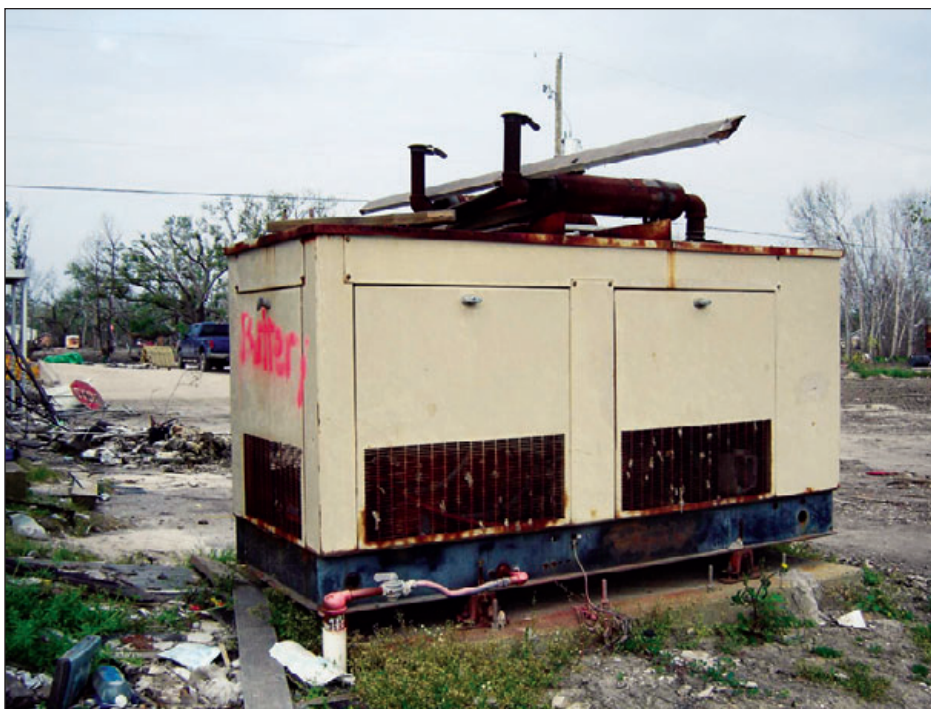
Figure 5-19: Although it was anchored and not displaced by floodwaters, this generator was out of service after being submerged (Hurricane Katrina, 2005)

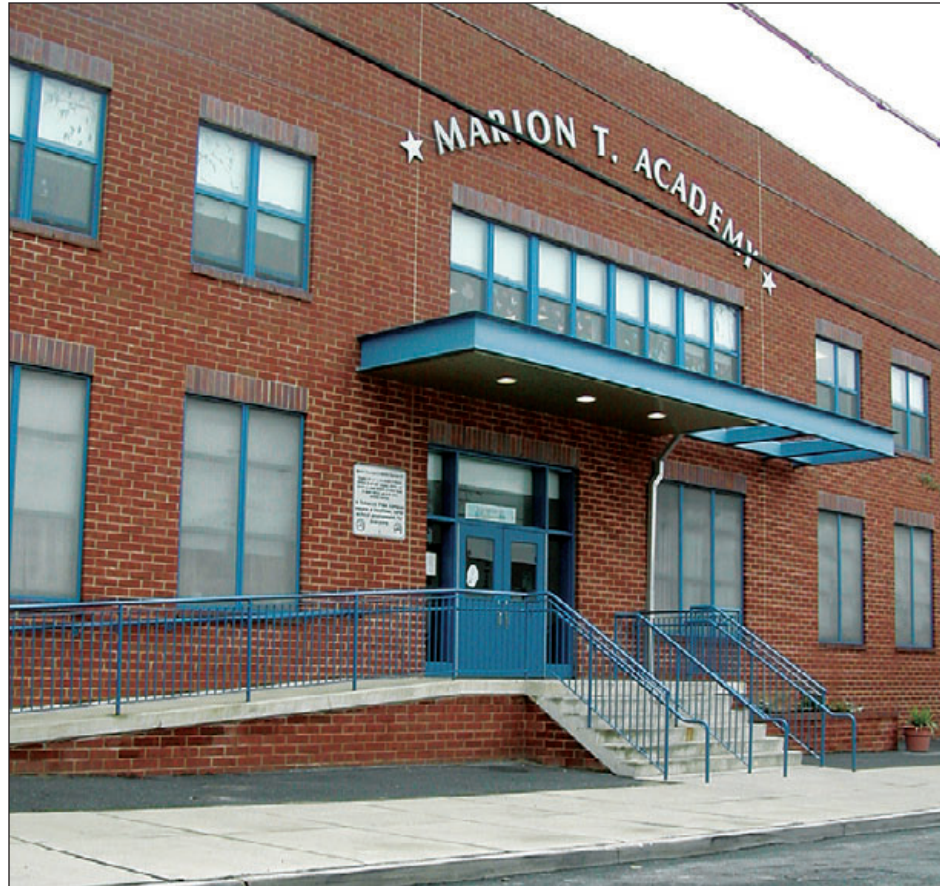
Figure 5-24:
School elevated on
columns

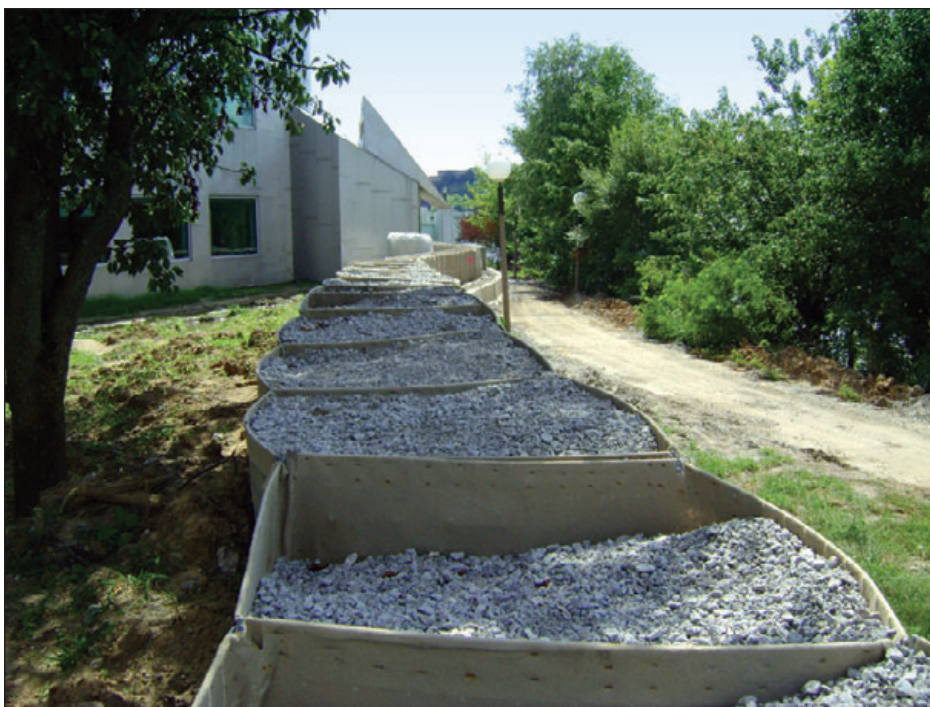
Figure 5-31:
Gravel-filled containers
form a barrier to protect
the University of Iowa
(2008)

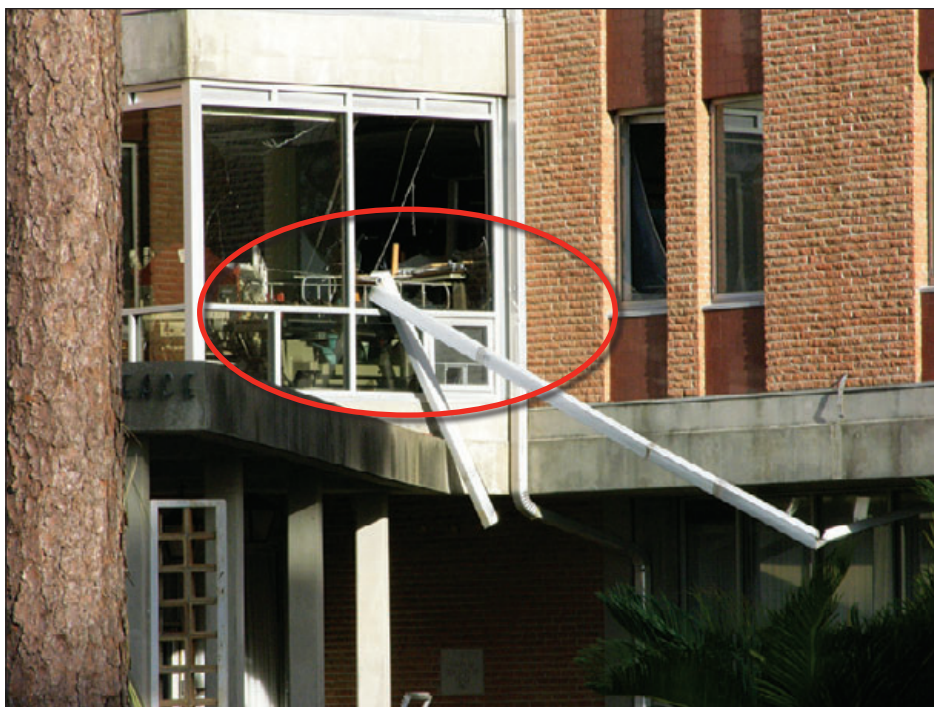
Figure 6-78:
Blow-off of this
downspout resulted
in glazing breakage.
Estimated wind
speed: 105–115 mph.
Hurricane Ivan (Florida,
2004)

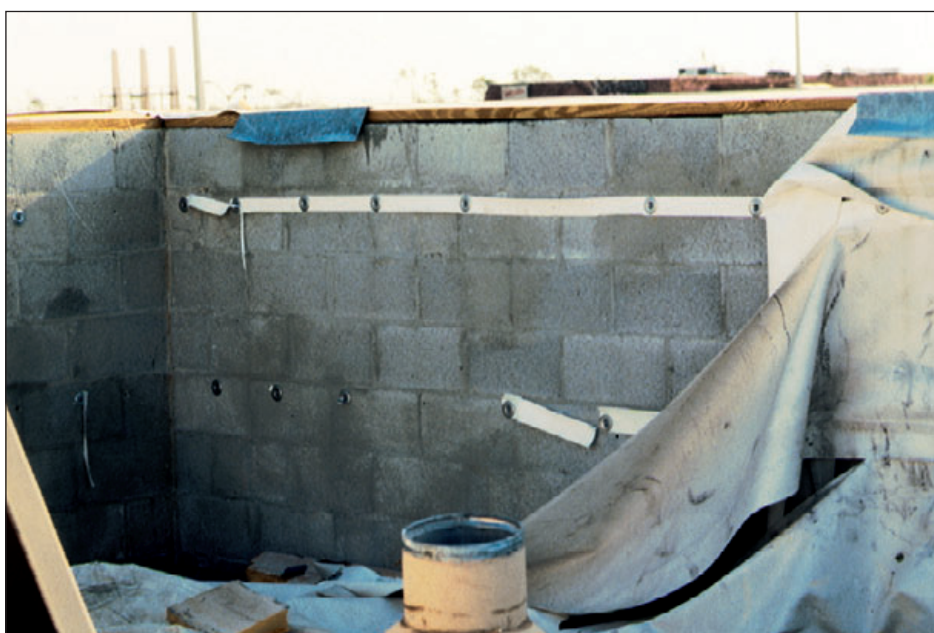
Figure 6-79:
If mechanically attached
base flashings have
an insufficient number
of fasteners, the base
flashing can be blown
away. Hurricane Andrew
(Florida, 2004)

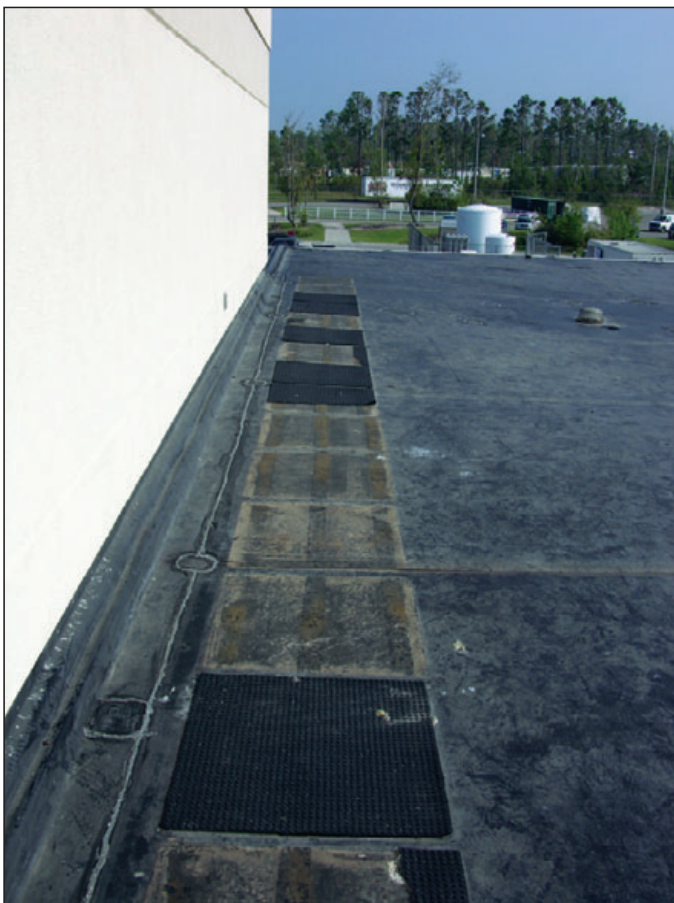
Figure 6-87:
Several rubber walkway pads were blown off the single-ply membrane roof. Estimated wind speed: 130 mph. Hurricane Katrina (Mississippi, 2005)

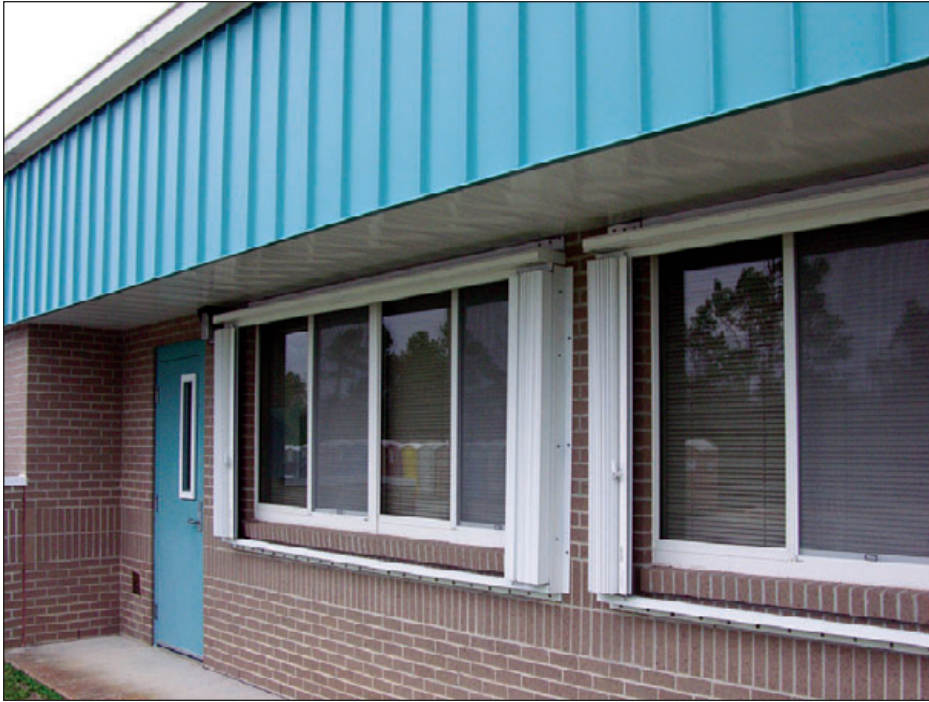
Figure 6-125:
This school has
accordion shutters.
Estimated wind
speed: 105–115 mph.
Hurricane Ivan (Florida,
2004)
